STORM DATA EXCERPT FOR HURRICANE ANDREW - AUGUST 1992

Damage Survey of Hurricane Andrew in South Florida by Ted Fujita

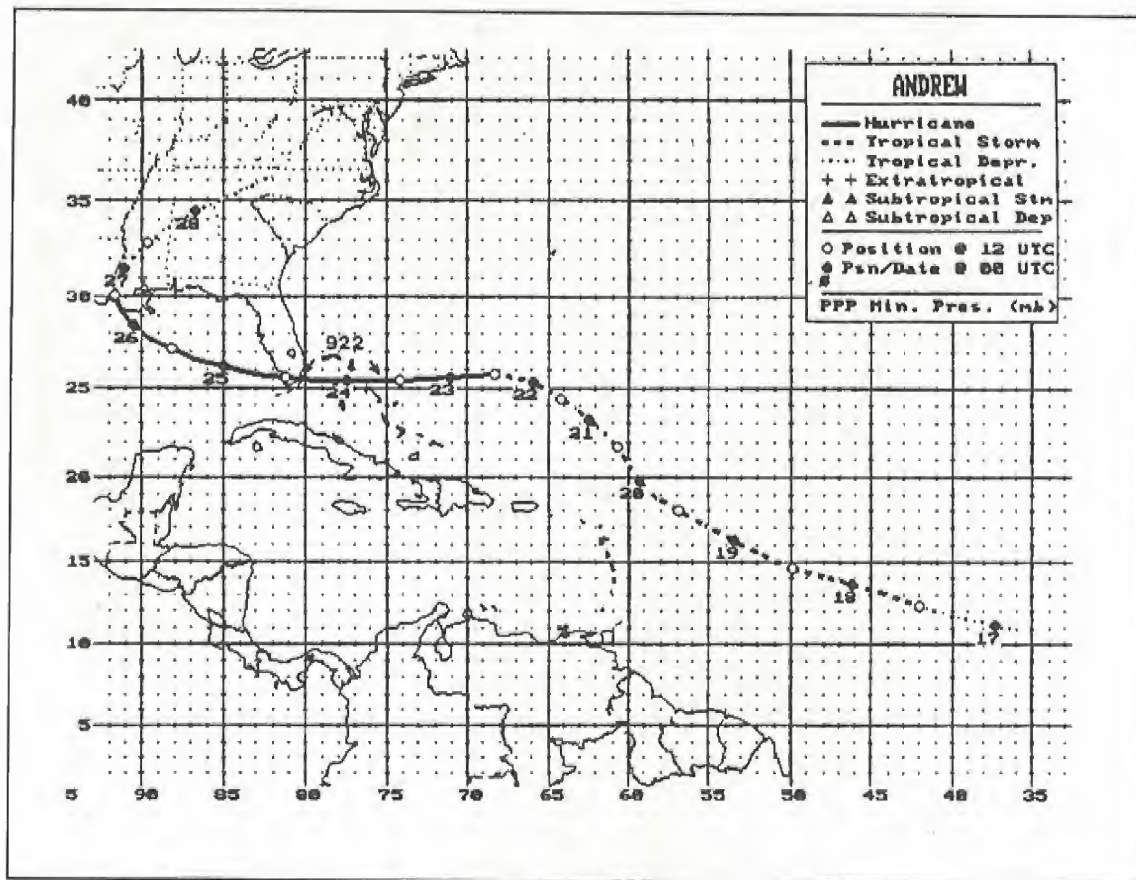
Best track positions for Hurricane Andrew.

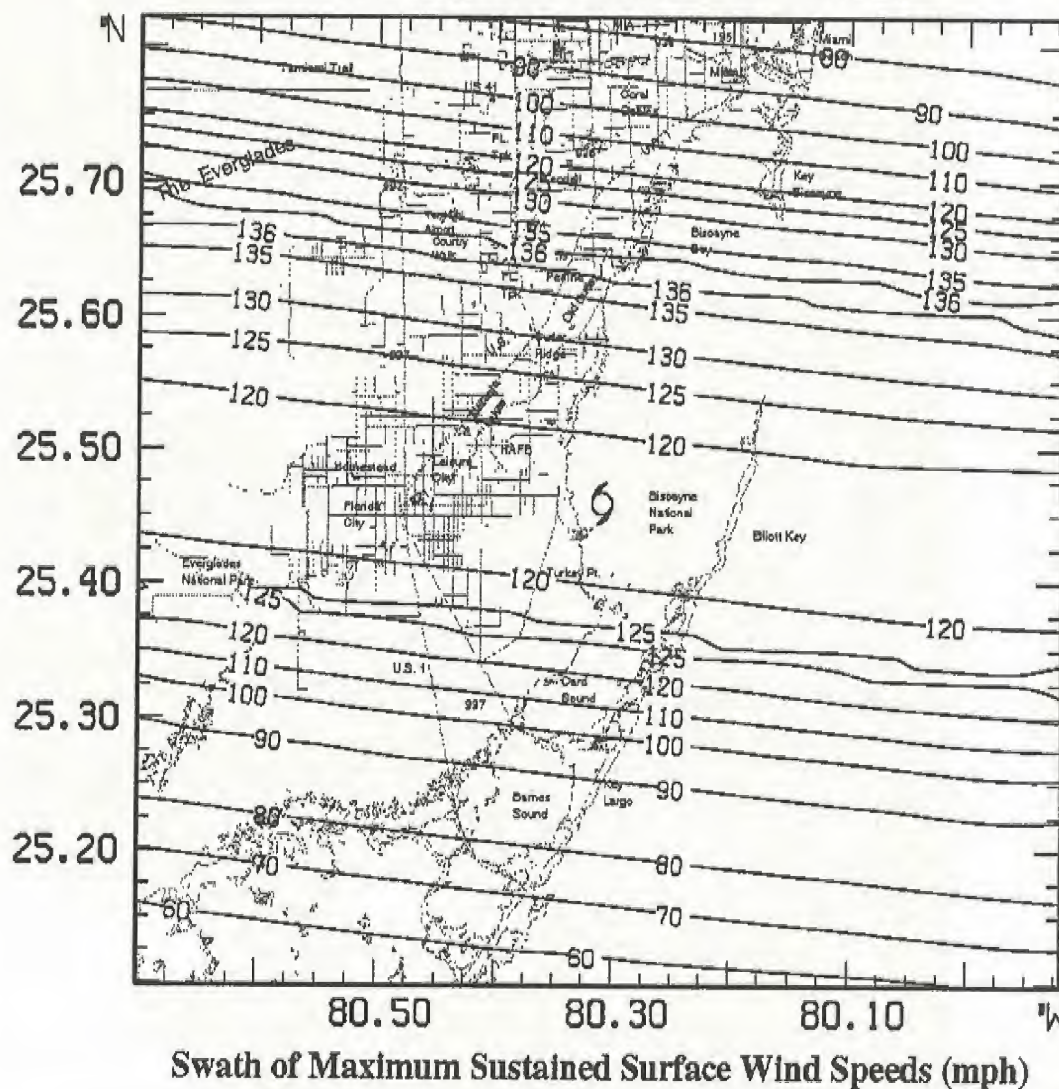
NOAA Hurricane Research Division Surface Wind Analysis Hurricane Andrew

Interpretation of the Above map: The wind swath represents contours of the highest sustained wind (a sustained wind is actually the average of lulls and gusts that occur over a 1 minute period) that would have been experienced at the map locations during Andrew. These winds represent open terrain exposure over land at the 10-meter level. Open terrain is similar to that of an airport runway. The lines over water are unrepresentative because those locations would have experienced even stronger winds due to less friction. The wind swath map **DOES NOT** represent a "snapshot" of the wind field at any instant of time. Analysis is based on surface measurements and Air Force reconnaissance winds adjusted to 10 meters with a boundary layer model.

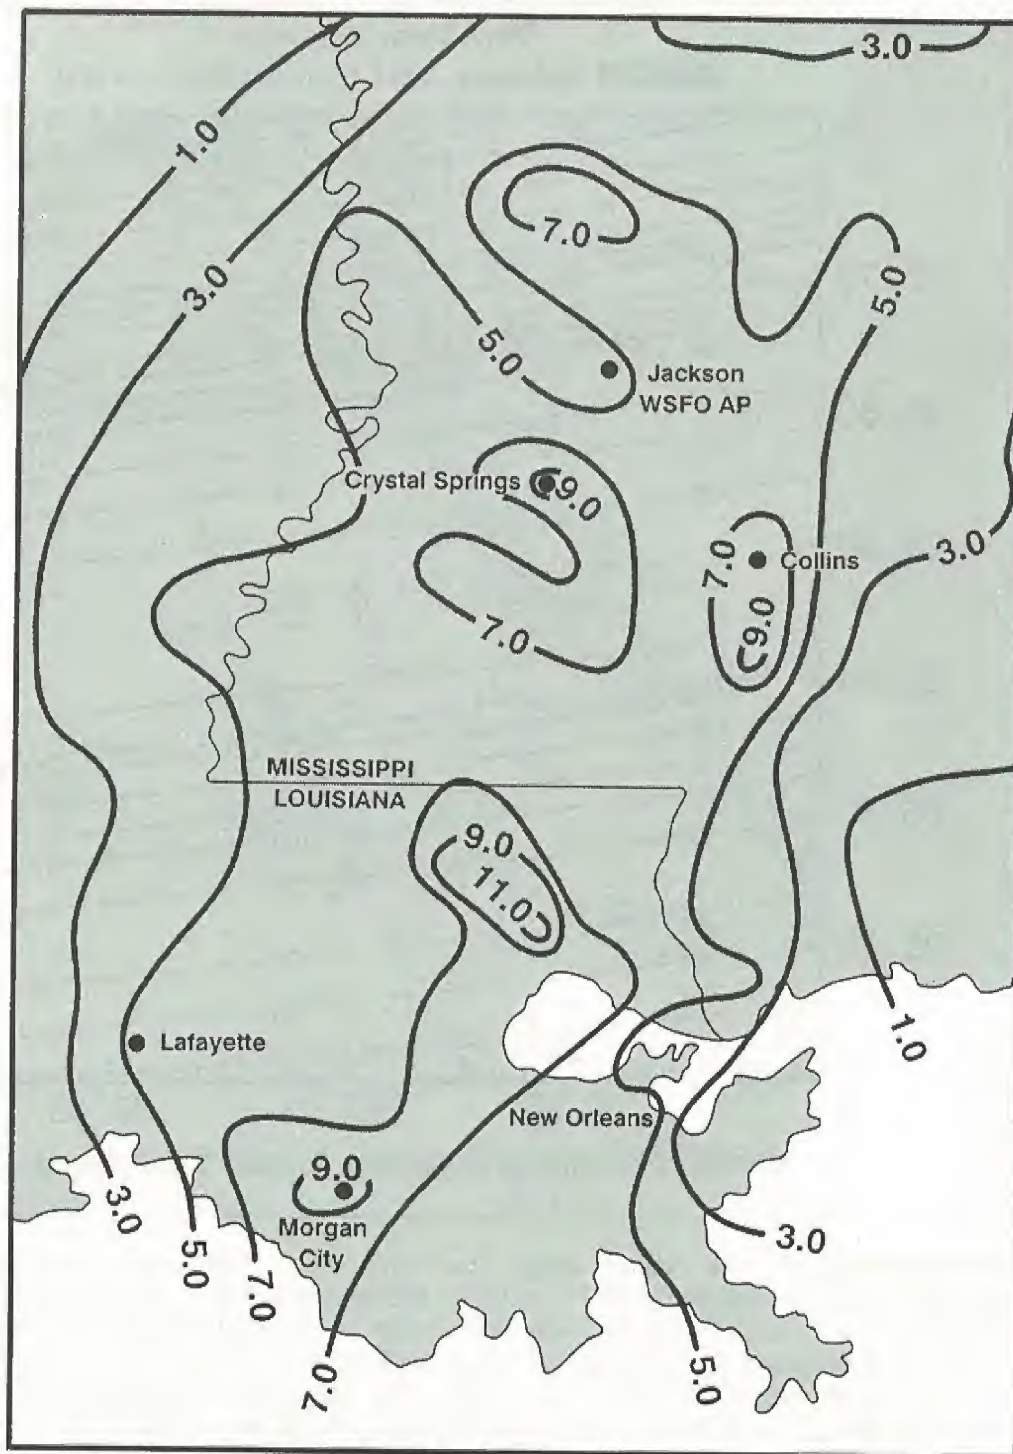
ANDREW RAINFALL OVER LOUISIANA AND MISSISSIPPI - AUGUST 25 - 28

Above: Map based on Cooperative Observer data supplied to the National Climatic Data Center, Asheville, North Carolina.

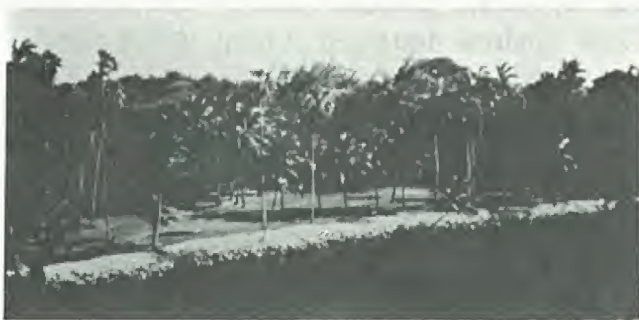
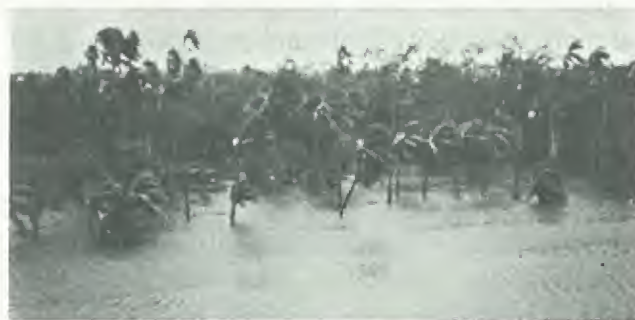
Above(left): Sewell Park before Andrew. **Above(right):** Sewell Park early morning of August 24. **Below:** The Gables-by-the-Sea marina located near Gables Estates where numerous boats were forced ashore by the 9 to 16 foot storm surge. Also note the downed trees. *(Photo courtesy: NHC)*

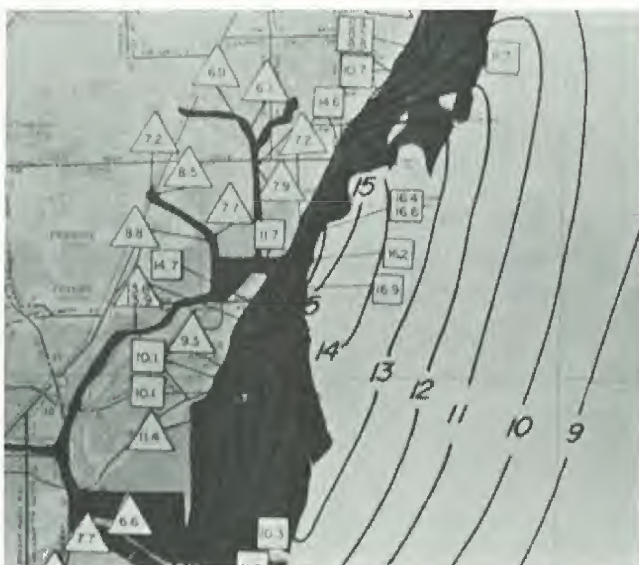
Above: An analysis of the maximum storm surge (feet) along the southeast Florida coast. A maximum storm tide of 16.9 feet, was recorded near the Burger King World Headquarters! *(Photo courtesy: NHC - Brian Jarvinen)* **Below:** Boat damage at Black Point Marina, Dade County. *(Photo courtesy: NHC)* **Right:** Sailboat stranded on a residential street in the Gables-by-the-Sea development of Coral Gables, Florida. *(Photo courtesy: Roger Edwards, Kansas City, MO.)*

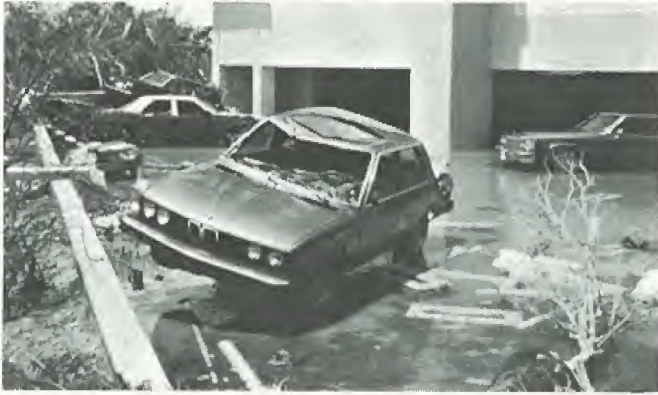
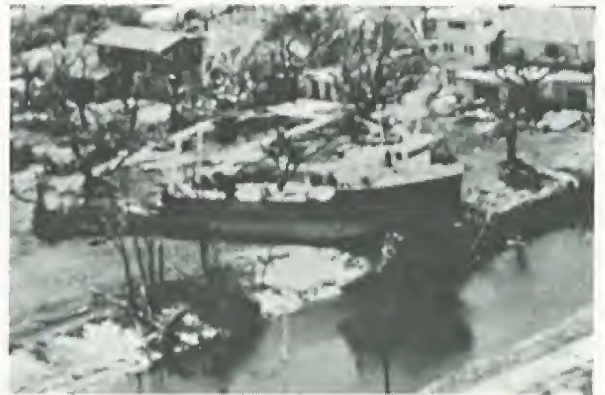
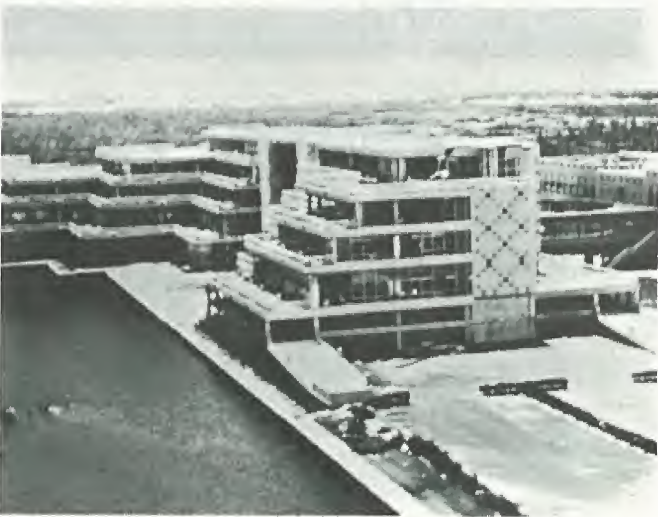
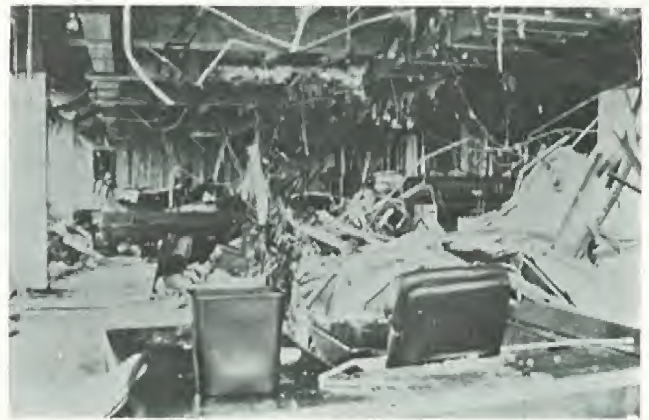
Top(left): Damaged vehicles at the Towers Condominium (Key Biscayne) adjacent to Cape Florida State Park. Note the flooded parking lot. (*Photo courtesy: Ralph Clark*) **Top(right):** The Seaward Explorer, an ocean-going tug, was forced ashore just south of the Deering Estate by the combination of wind and storm surge. **Above(left):** An aerial view of the World Headquarters for Burger King. Note the number of windows blown out by the strong winds. **Above(right):** Wind damage to the Chief Executive Office located on the top floor of the Burger King World Headquarters. **Below(left):** Water and wind damage to the main floor of the building. **Below(right):** Damage to homes in "Saga Bay" resulted from both the winds and storm surge. (*Photo courtesy: NHC*)

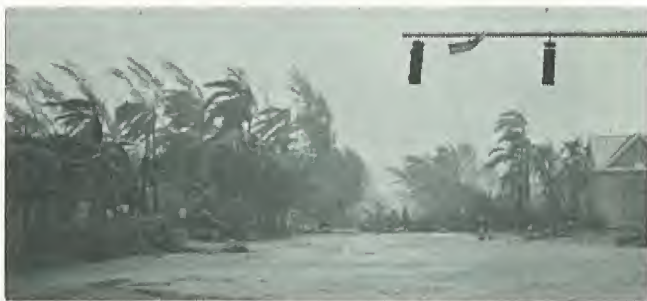
Above: Winds still gusting to 50 mph bend the remaining trees at Coconut Grove after the passage of Hurricane Andrew. *(Photo courtesy: Steve Wachholder)*
Above(right): Broken pine trees in the Pinewoods Villa development indicate the different directions of the first and second winds. *(Photo courtesy: Roger Edwards)*

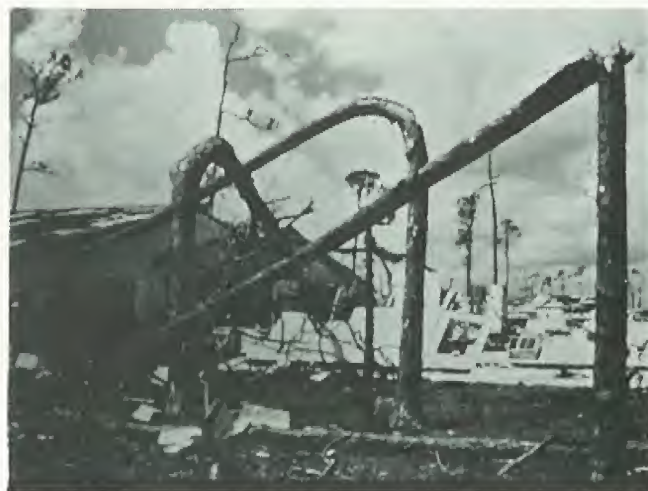
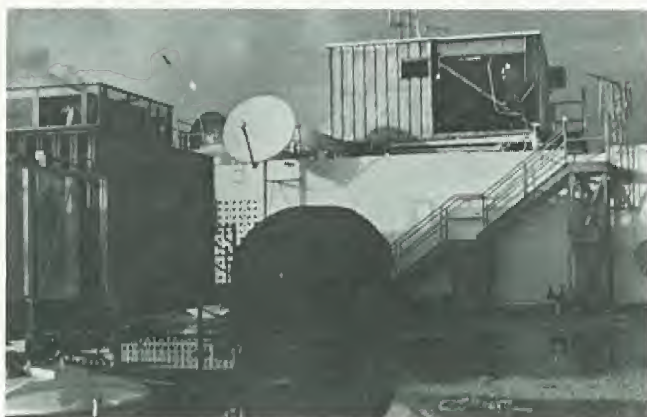
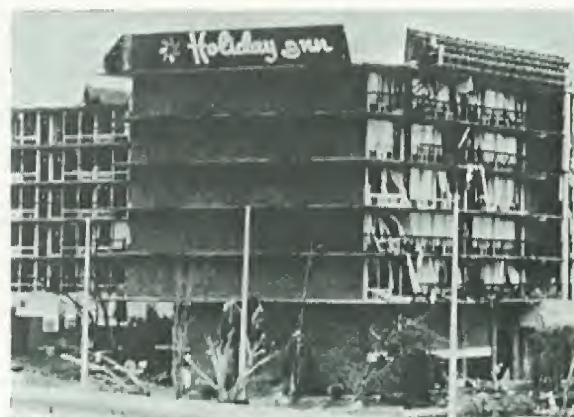
Above: A view of some of the wind damage to NHC's communications equipment atop the IRE Financial Building. The radar dome of the WSR-57 weather radar was blown off the highest structure seen at the center right of the photograph. *(Photo courtesy: Roger Edwards)* **Above(right):** The Holiday Inn at Cutler Ridge, north of Homestead, suffered extensive wind damage with nearly every window blown out! *(Photo courtesy: NHC)* **Below(left):** Outside wall almost completely removed from the east side of an apartment building in the Saga Bay development, near Cutler Ridge. **Below(right):** Partial removal of the outside wall from the south (right) and west faces of the building. *(Photo courtesy: Roger Edwards)*

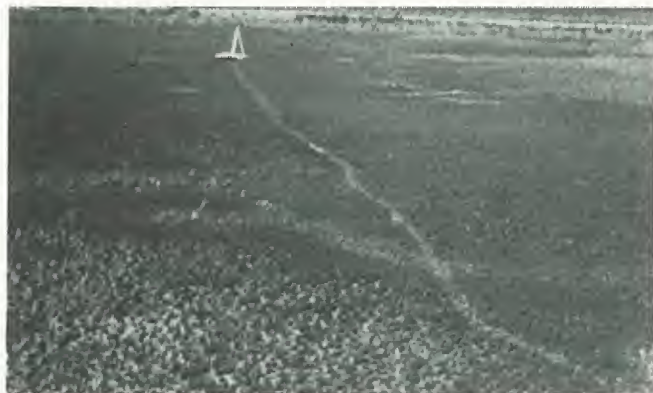
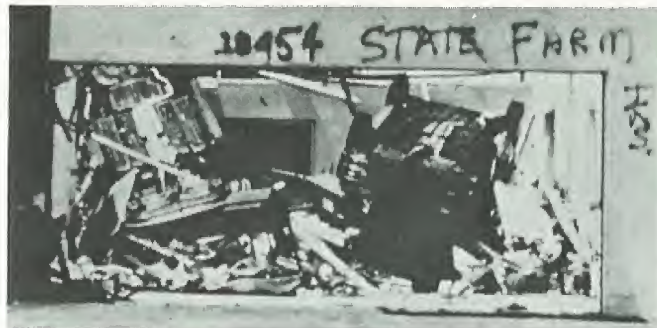
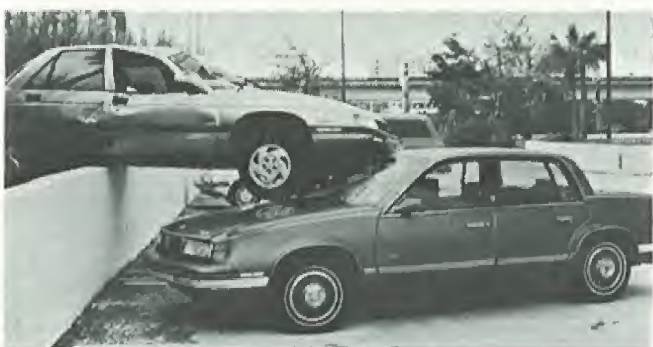
Top(left): Hurricane force winds blew this sailboat well inland. The photograph was taken south of Homestead Air Force Base. **Top(right):** The wind overturned the two cars in this garage, located west of

Whispering Pines. **Above:** Two cars lifted and moved by the wind. The cars had been parked next to the IRE Financial Building. **Right:** A royal palm tree in the Homestead area that was penetrated by a foreign object. The object was a 1 x 4 inch board which penetrated the tree about 40 feet above ground level. (Photo courtesy: Roger Edwards)

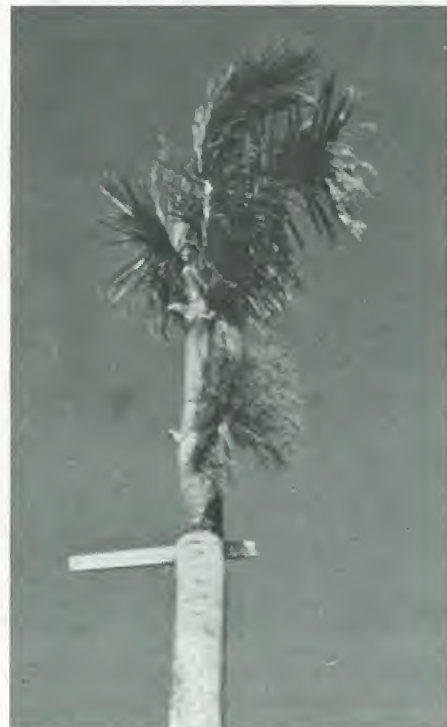
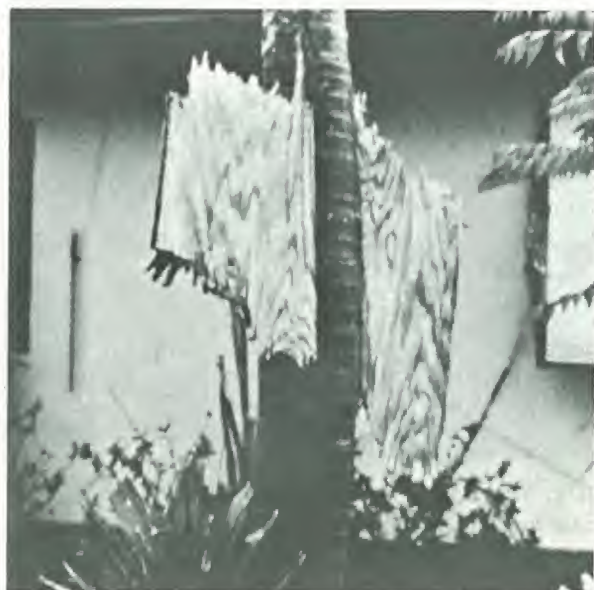
Right: An 18-inch wide structural I-beam bent and twisted in the Naranja community. (Photo courtesy: Ralph Clark) **Left:** Another royal palm tree near Homestead was pierced by a wind driven sheet of plywood. (Photo courtesy: NHC)

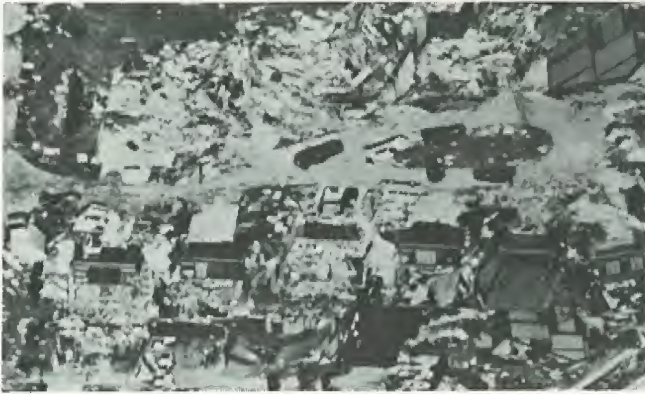
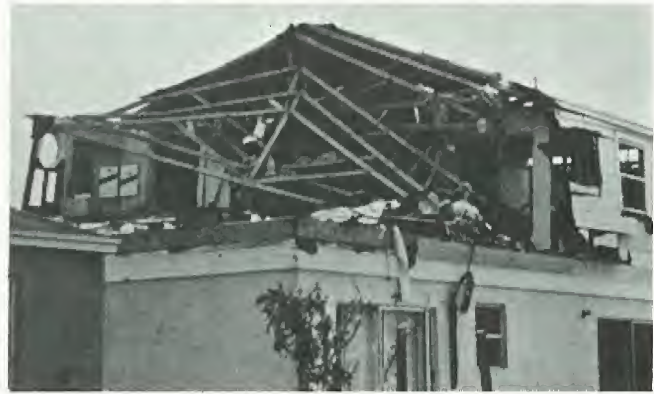
Above(left): This aerial view depicts the uneven damage pattern found in various wood structures in the Lakes By the Bay residential development. **Above(right):** A close-up view of a home in the development. The gable end of the roof failed during the storm. This was a frequent problem in homes of mixed wood and concrete block construction. *(Photo courtesy: NHC)*

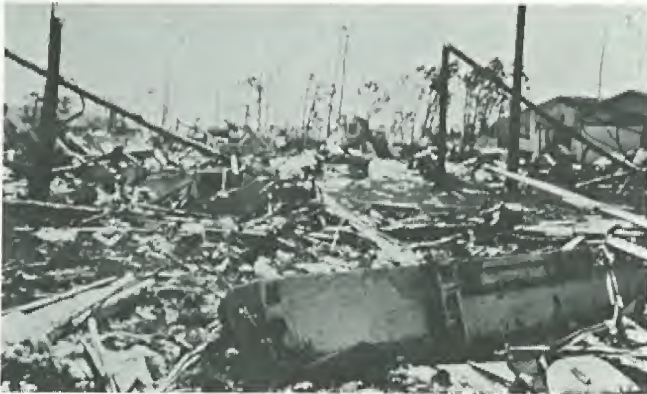
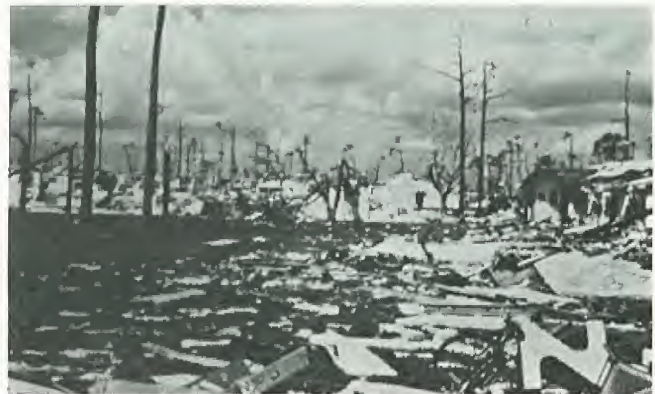
Above(left): Ground view of the devastation in the Pinewoods Villa. In the foreground are broken segments of a large tie beam. **Above(right):** Another ground level view in the Pinewoods Villa. *(Photo courtesy: NHC)*

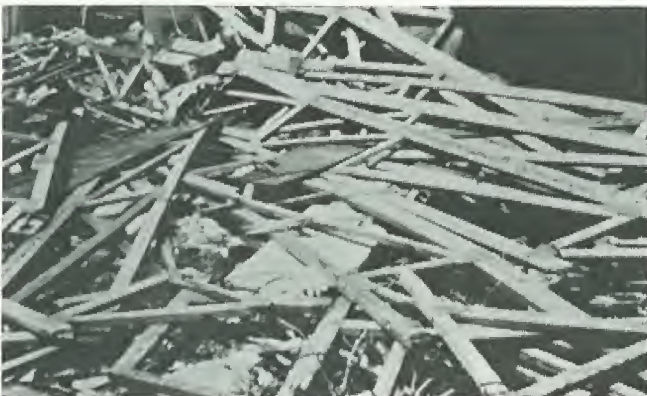
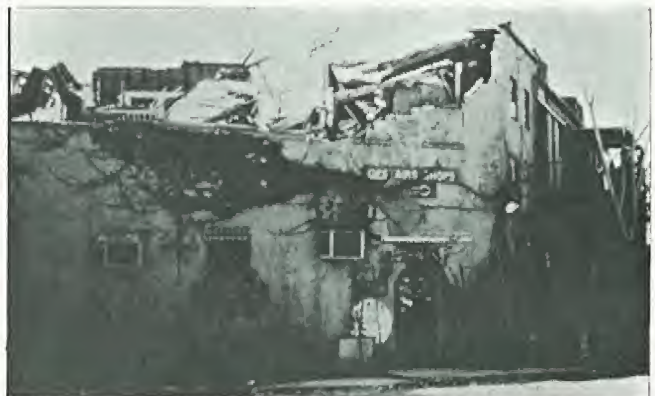
Above(left): Many roof trusses failed during the hurricane force winds. **Above(right):** These rustic shops were part of Gauley Square, a shopping area located north of Homestead. Both new and old buildings suffered significant damage. *(Photo courtesy: NHC)*

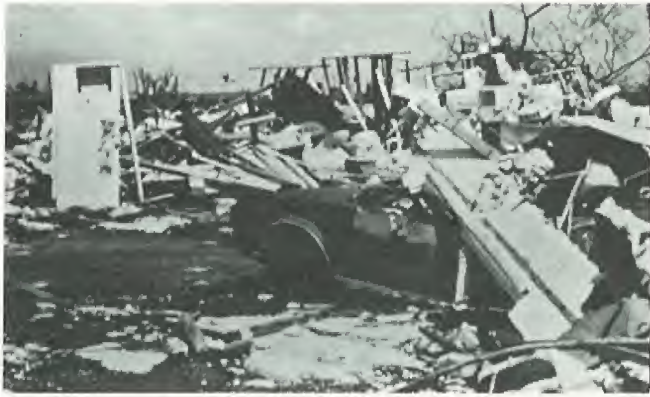
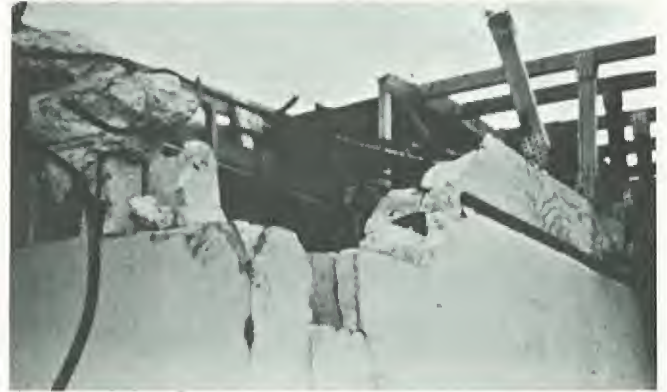
Above(left): Naranja Lakes homes were primarily concrete block and stucco (or CBS) construction. The force of Andrew's wind was strong enough to lift concrete tie beams and propel them into nearby structures. **Above(right):** This home in Naranja Lakes shows inadequate tie beam construction. Note that there were no vertical ties to the foundation. Many homes in Naranja Lakes lacked any vertical tie columns. *(Photo courtesy: NHC)*

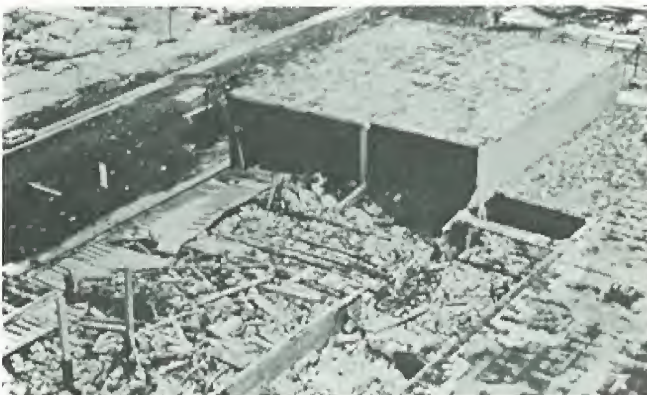
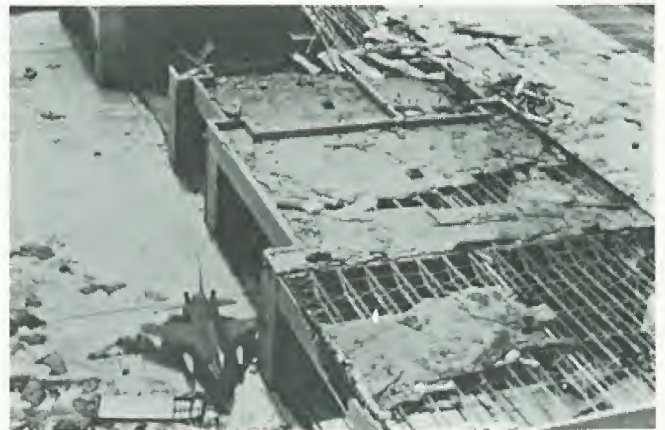
Above(left): An aerial view of the remnants of a Levitz Furniture Warehouse and Showroom located along U.S. 1, west of the community of Whispering Pines. **Above(right):** Fortunately, most of the planes at Homestead Air Force Base had been flown out before the storm, however this F-16 fighter was under repair at the time and had to be left behind. *(Photo courtesy: NHC)*

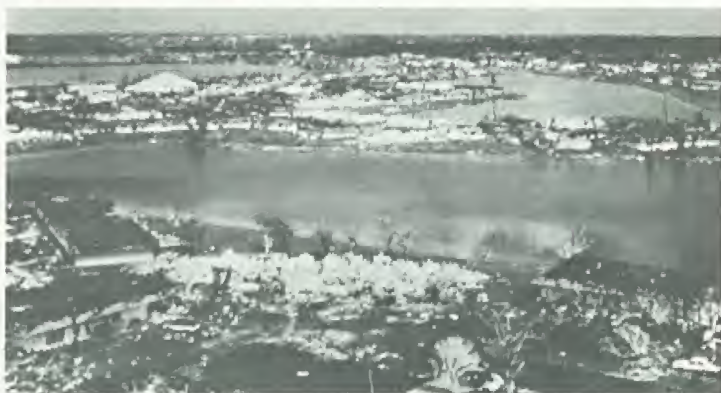
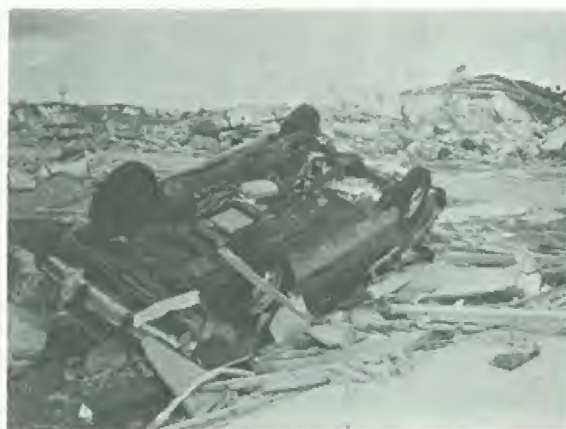
Above(left): An aerial view of a damage streak through Naranja Lakes, located between Cutler Ridge and Homestead. These damage streaks were evident throughout the hardest hit areas of south Florida. The streak in this photograph extends in to the distance from the center foreground. *(Photo courtesy: NHC)* **Above(right):** Extreme wind damage at a mobile home community in Homestead. The Homestead water tower, distant left in the photograph, became the major remaining landmark after the hurricane. *(Photo courtesy: Ralph Clark)*

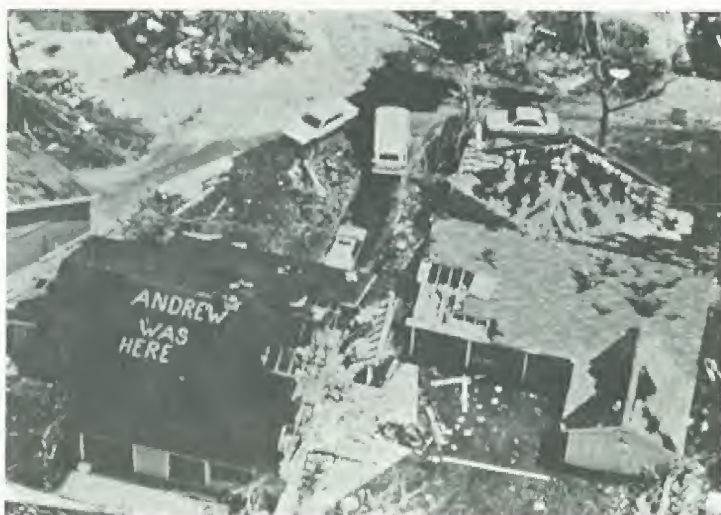
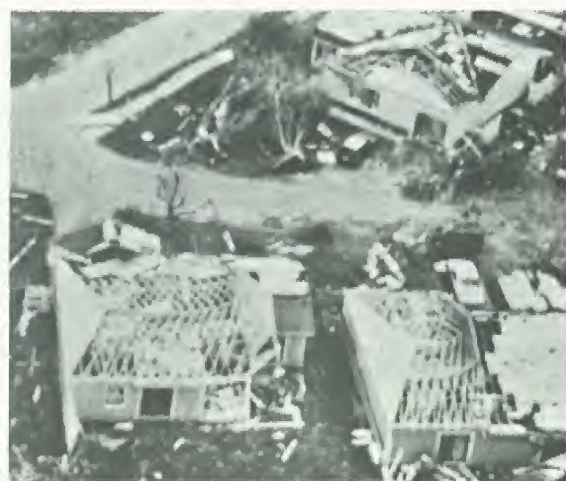
Above(left): Despite the devastation, some residents of Country Walk exhibited a sense of humor. **Above(right):** The roof structure of many homes in Country Walk development failed because of unsupported gables. *(Photo courtesy: NHC)*

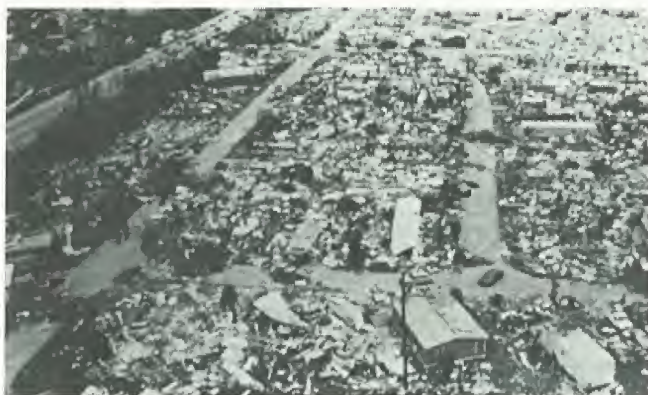
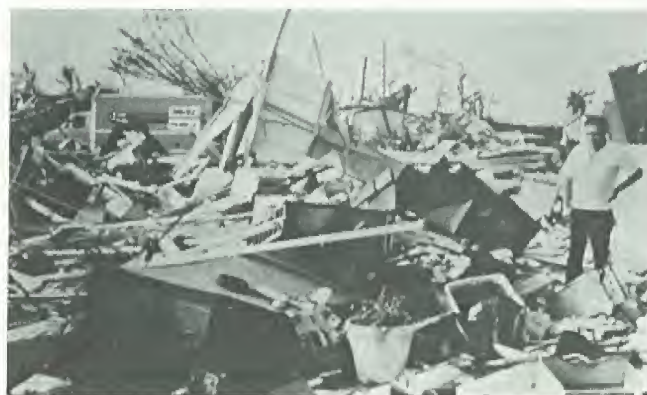
Above(left): An aerial view of the damage to the Dadeland Mobile Home Park. **Above(right):** A ground view of the same damage. *(Photo courtesy: NHC)*

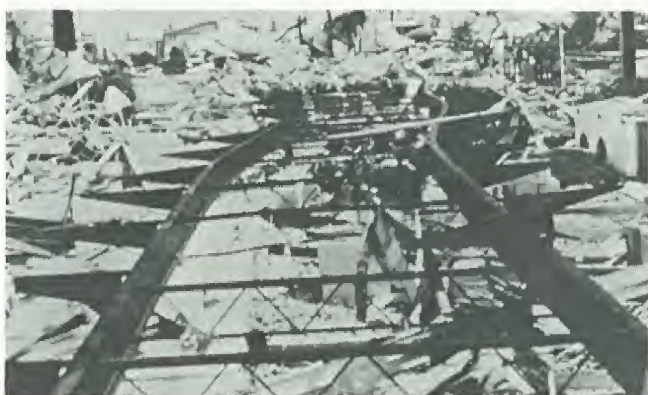
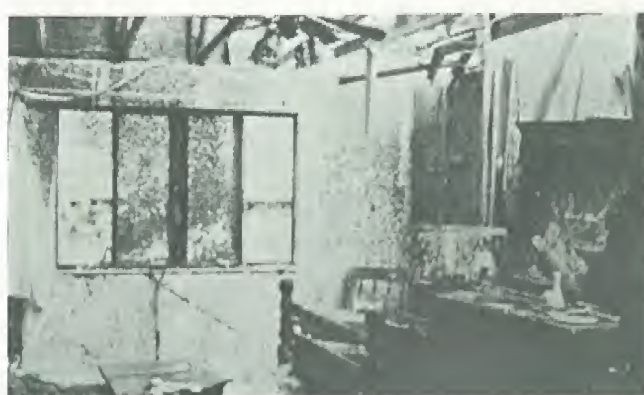
Above(left): The frame is all that remains of this mobile home. This demonstrates the high risk to residents who must ride out severe wind storms in such a structure. **Above(right):** A damaged home in the Saga Bay development clearly shows the damage inflicted by high wind and heavy rain. Insulation is splattered across the bedroom walls. *(Photo courtesy: NHC)*

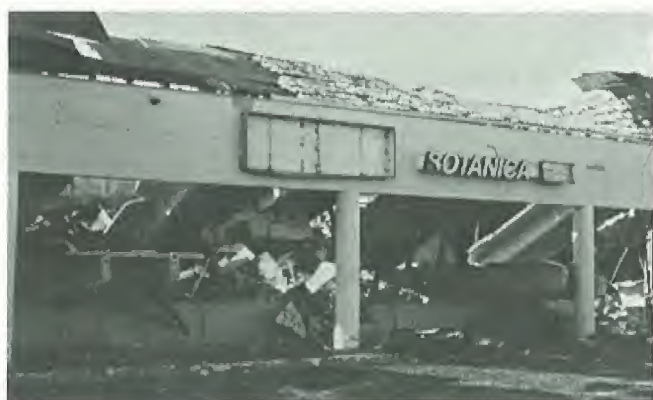
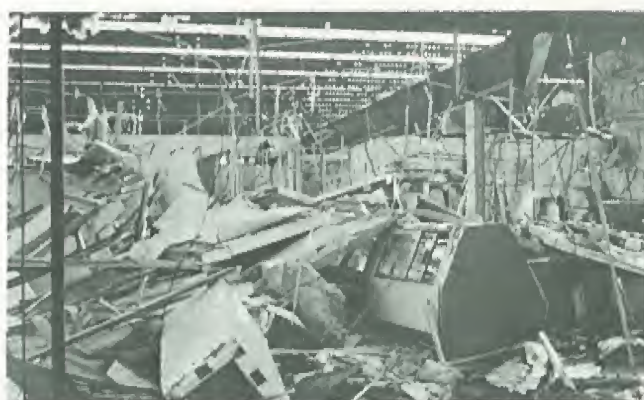
Above(left): Front view of the east (windward) face of a strip shopping center on the north side of Quail Roost Drive, near the Florida Turnpike. Winds flowing in through the broken plate glass windows, pushed the walls outward a sufficient distance to allow the pre-cast concrete roof to fall into the store. **Above(right):** View of the rubble inside a "Food Stop" convenience store, at the same shopping center. *(Photo courtesy: Roger Edwards)*

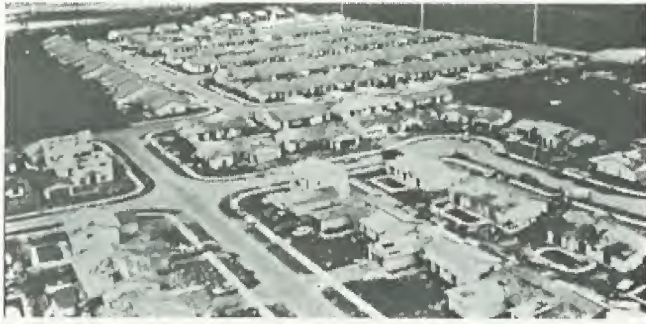
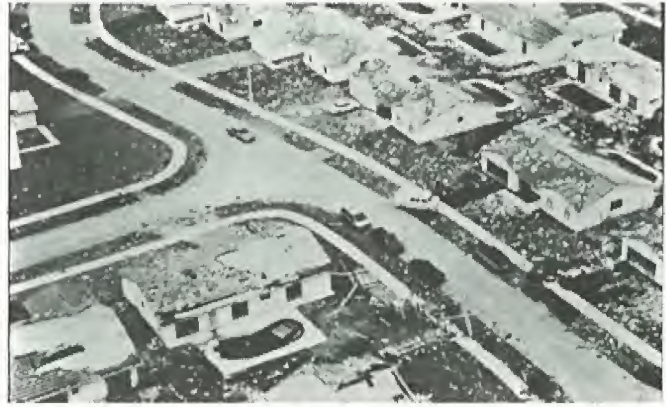
Above(left): This aerial view shows a large contrast in damage between neighboring developments. The development in the background sustained heavy damage while those in the foreground only experienced minor damage. Both were constructed of concrete block and stucco, however the integrity of construction was significantly different. **Above(right):** A closer view of the well built homes. Most of the homes lost shingles,

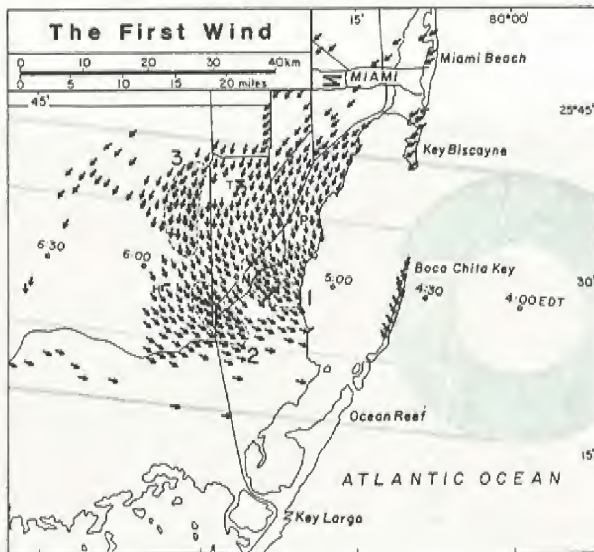
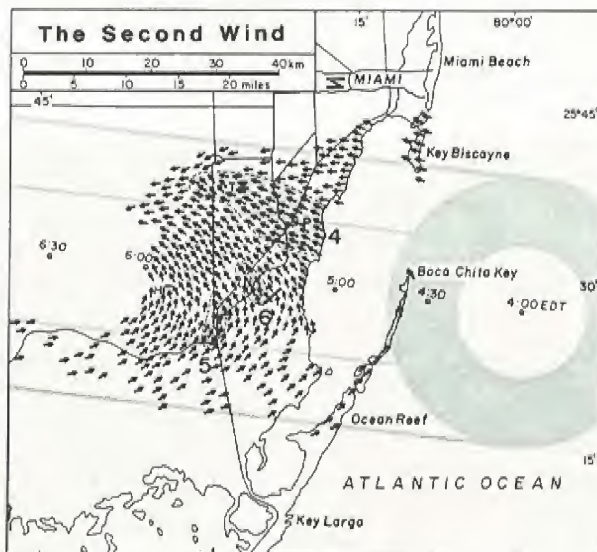
Above: Direction of the first damaging wind occurring during the approach phase of Andrew. Below: Damage by the second wind, during the receding phase.

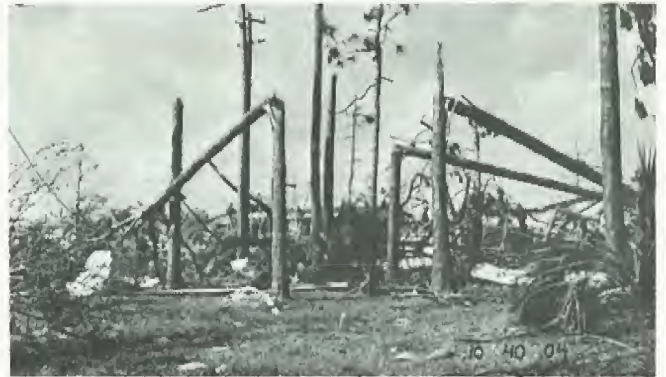
Typical damage of pine trees caused by the first and second winds. Numerous Australian pines were blown down by the first wind. Fujita photo 1040 EDT 9/9/92

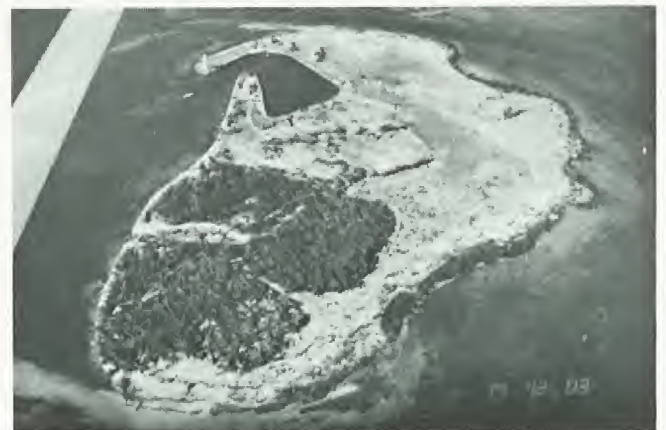
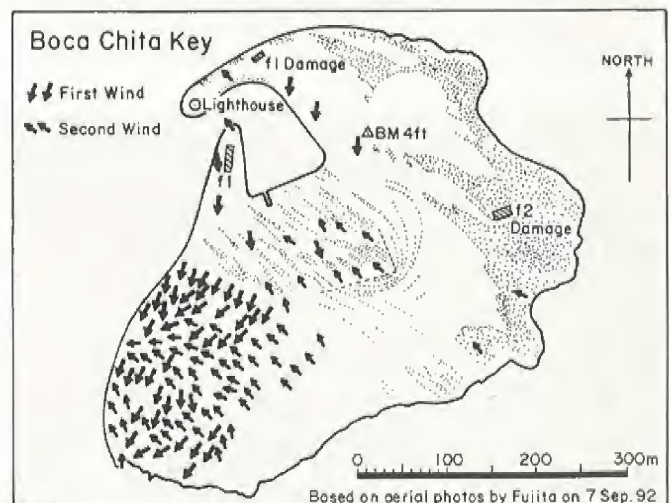
Above: Boca Chita Key, 2 to 3 miles north of the eye center, received the first storm fury. Fujita photo 1742 EDT 9/7/92. Below: Damage map showing the average direction of the first wind from 10° and the second wind from 125°.

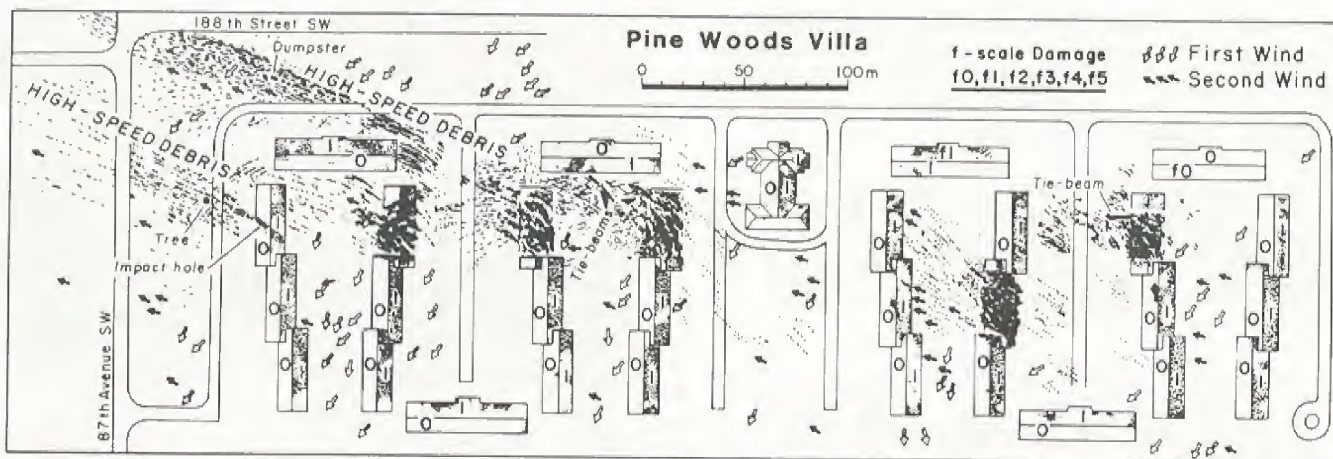
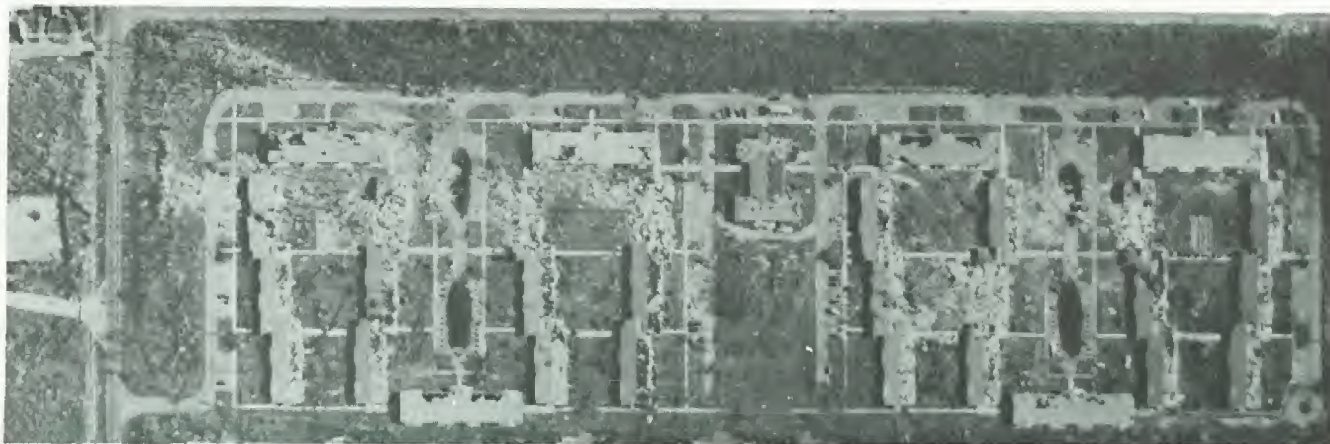
Mini-swirl Damage at Pine Woods Villa Southeast of 188 St and 87 Av SW

Above: Structural and tree damages at the Villa located inside the Tamiami Swath. Although trees were damaged by both first and second winds, the first wind did not cause structural damage, suggesting that the first wind was weaker than the second wind in the Tamiami Swath. The second wind caused the f1 damage to the east-side roofs while west-side roofs were not damaged (f0).
Below: An enlarged view of a 9"X9" vertical photo taken by Continental Aerial Survey on 8/27/92.

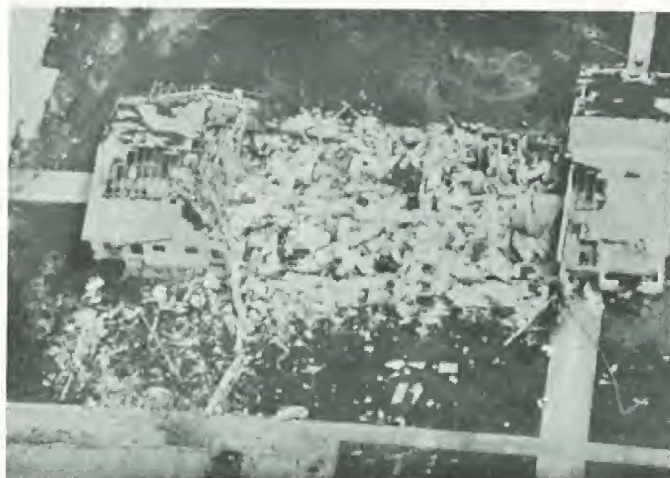
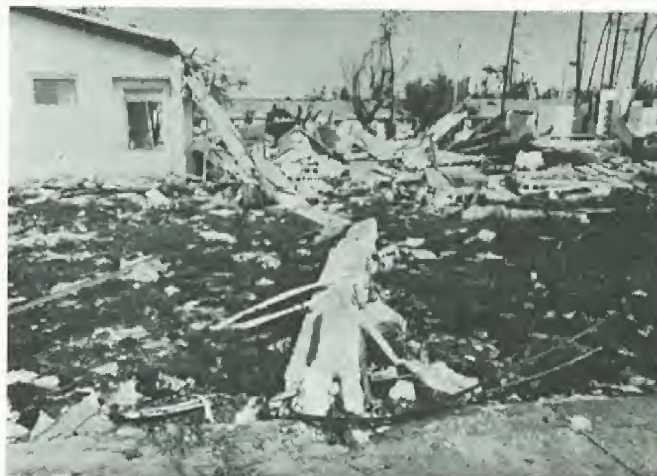
Left: Aerial photo of a tie-beam (see map) blown off toward the west. Fujita photo 1245 EDT 9/14/92.
Right: Ground view of the tie-beam reinforced with one-inch steel rods. Fujita photo 1649 EDT 9/15/92.

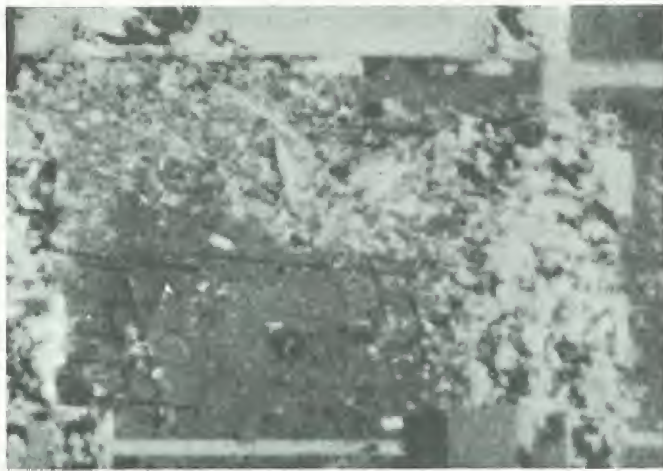
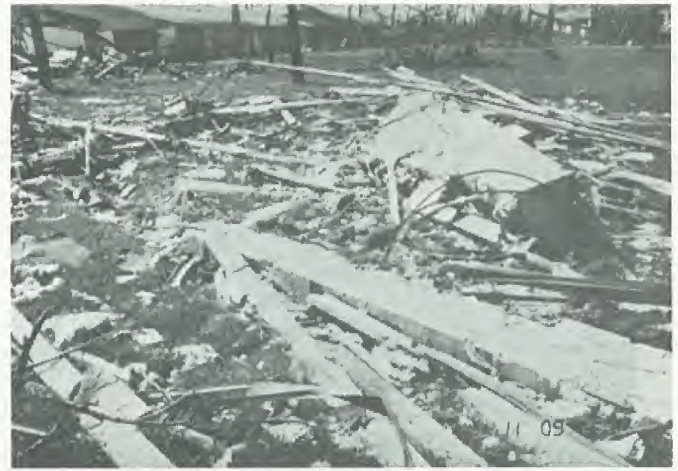
Left: Tie-beams at Pine Woods Villa (see map) blown apart by a mini-swirl. Continental Aerial Survey photo taken on 8/27/92. **Right:** Ground view of the tie-beams. Fujita photo 1109 EDT 9/9/92.

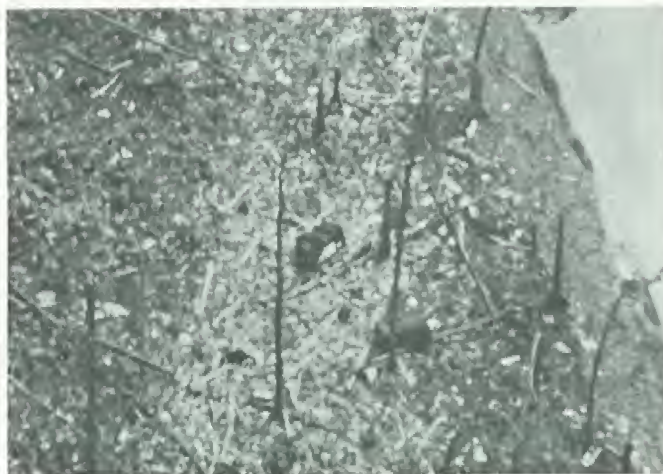
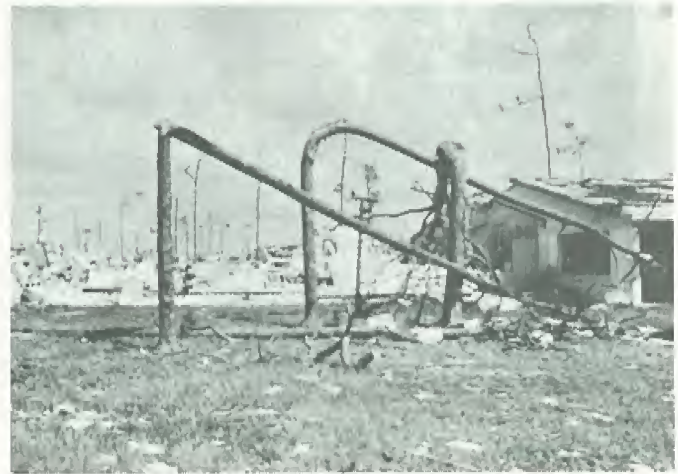
Left: A dumpster found inside the high-speed debris (see map). Some trees in this photo were blown down by both first and second winds. Fujita photo 1234 EDT 9/14/92. **Right:** Bi-directional tree damage seen near the dumpster site. Fujita photo 1109 EDT 9/9/92.

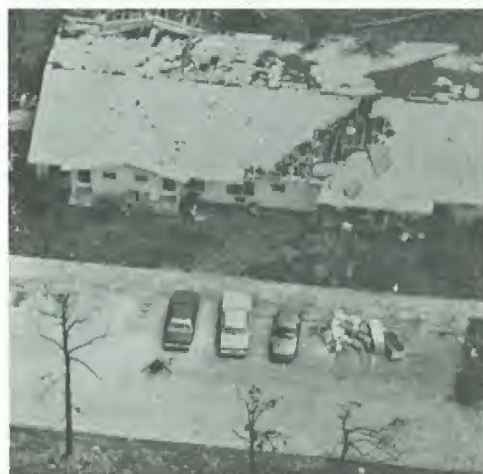
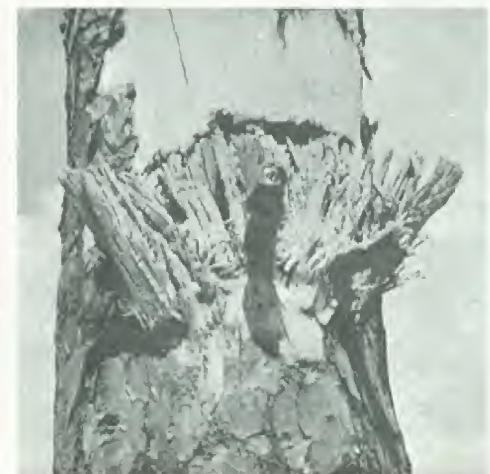
Left: An impact hole (see map) created by a falling tie-beam. Fujita photo 1245 EDT 9/14/92. A piece of flying plywood cut through the trunk of the tall pine tree shown at the lower left of the picture. **Center:** Drs. Robert Sheets and Peter Black examining the tree trunk. **Right:** A close-up view of the deep cut. Fujita photos 1057 EDT 9/9/92.

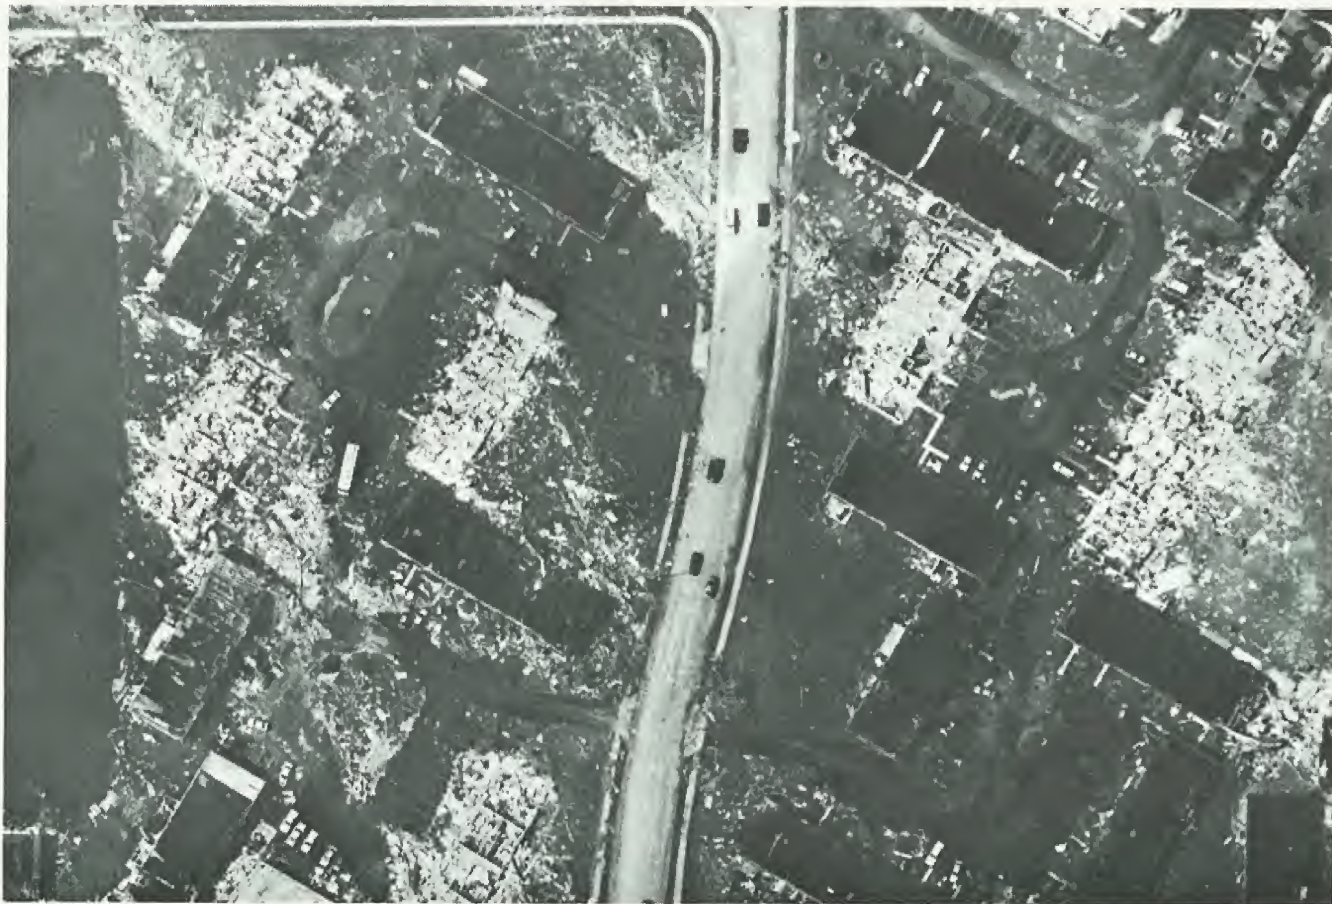
Condos at Naranja Lakes in Wind-parallel and Perpendicular Directions

Center of Andrew's eye passed directly over Naranja Lakes, resulting in a 180° shift of the first wind from NNW into the second wind from SSE. Many buildings oriented WSW-ENE (wind-perpendicular) direction received the f3 damage while those in the NNW-SSE (wind-parallel) direction were spared. Enlargement of a Continental Aerial Survey photo taken on 8/26/92.
